**Flood Control Project Maintenance
Levee Inspections**

Spring 2015 Levee Inspection Results

Yolo County Service Area 6

Waterway			Bank	Unit Miles
Unit No. 01 Right Bank of Sacramento River at Knights Landing			Right	5.87
	Spring (March - May)	Summer (June - August)	(September - November) Fall	Winter (December - February)
Unit Maintenance Rating (Fall Only)				
Date of Inspection	05/26/2015 - 05/26/2015			
DWR Inspector	Jai Lor			
Accompanied By	Chris Starke Yolo County

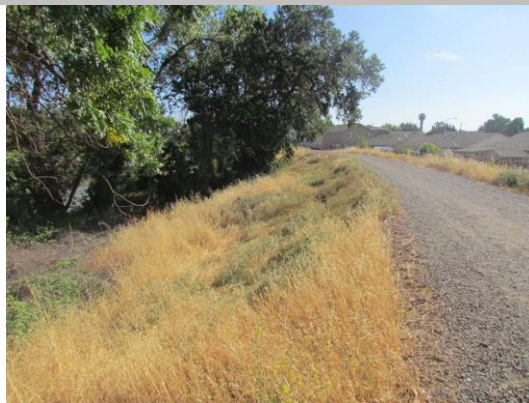
Photo 1 of 1 : SP_2015_NA0022_350_69_20150528_00061.jpg

View of the vegetation on the waterward side of the levee looking downstream. Spring 2015.

LM Start	0.03	Rating **	C	Issue No.	13
LM End	0.20	Issue Type +	Ma	Location *	CR
Category	Earthen Levee			GPS Latitude/Longitude	
				Start	End
Item	Vegetation			38.799500 °	38.801298 °
				-121.724098 °	-121.722144 °
DWR ID	DWR_NA0022_01_s _ 2014_13				
Action/Comments					
Keep the crown roadway free of vegetation.

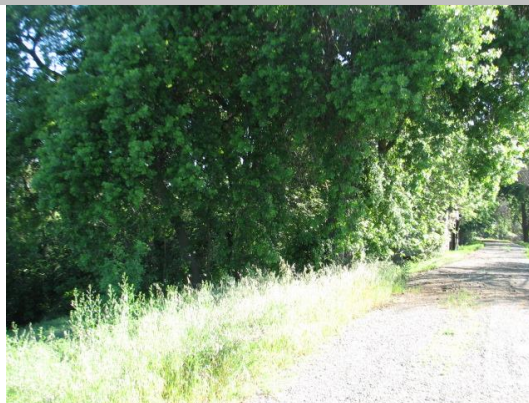
Photo 1 of 1 : SP_2015_NA0022_350_6_20150401_00010.jpg

Tall vegetation and trees block visibility. Spring 2014

LM Start	0.13	Rating **	M	Issue No.	402
LM End	0.13	Issue Type +	En	Location *	WS
Category	Supplemental			GPS Latitude/Longitude	
				Start	End
Item	DWR UCIP Field Study			38.800647 °	38.800647 °
				-121.723212 °	-121.723212 °
DWR ID					
Action/Comments					
Inspector Comments: FS_ID:31903 DS_ID:19515 EP_NO: 9425 Repair Type: Non-Urgent Crossing Status: Found UCIP Comments: Need to properly abandon crossing per Title 23-- pipe has been disconnected. No signs of pipe visible on waterward and landward sides. Need to contact owner to determine additional information about pipe section through levee. FIELD_STRUCT_DESC: Abandoned 8-inch steel pipe through the levee, 3.0-feet below the crown. Pump structure in channel. (ABO Permit No. 9425-1974). FS Date: 03/04/2014

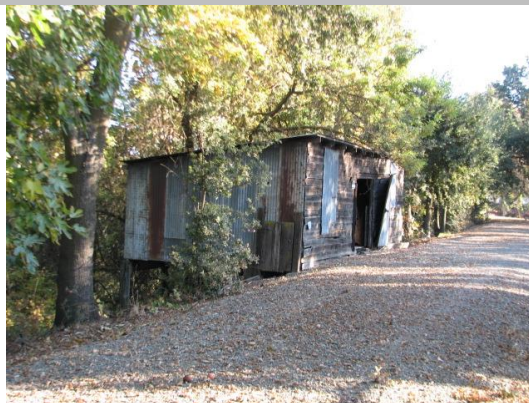
Photo 1 of 1 : SP_2015_NA0022_350_29_20150401_00033.jpg

The old barn is on the waterside of the levee. Fall 2013

LM Start	0.20	Rating **	M	Issue No.	403
LM End	0.20	Issue Type +	En	Location *	WS
Category	Supplemental			GPS Latitude/Longitude	
				Start	End
Item	DWR UCIP Field Study			38.801280 °	38.801280 °
				-121.722000 °	-121.722000 °
DWR ID					
Action/Comments					
Inspector Comments: FS_ID:31904 DS_ID:19516 EP_NO: N/A Repair Type: Non-Urgent Crossing Status: Indicator Found UCIP Comments: Need to properly abandon per Title 23 if corssing is no longer used--debris inside concrete box and near site. Need to contact owner. FIELD_STRUCT_DESC: 48-inch CM pipe through the levee, 14.5-feet below the crown. Slide gate in concrete box on the waterward bank. (ABO Permit - 1976). FS Date: 03/04/2014

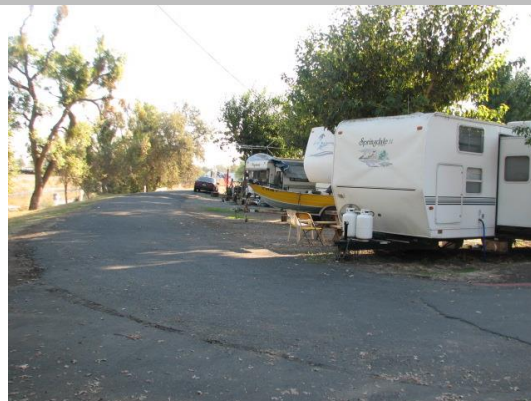
Photo 1 of 2 : SP_2015_NA0022_350_28_20150401_00031.jpg

The RV park is encroached into the levee crown. Fall 2013

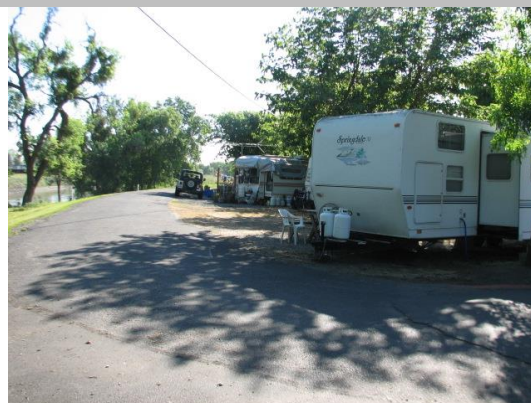
Photo 2 of 2 : SP_2015_NA0022_350_28_20150401_00032.jpg

Trailers on the crown of the levee. Spring 2014

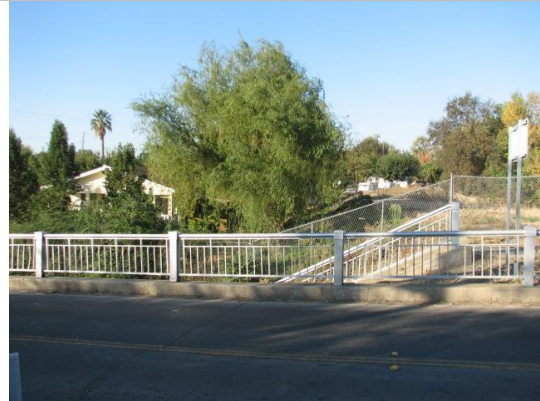
Photo 1 of 1 : SP_2015_NA0022_350_27_20150401_00030.jpg

Landscaping is encroach into the levee easement. Fall 2013

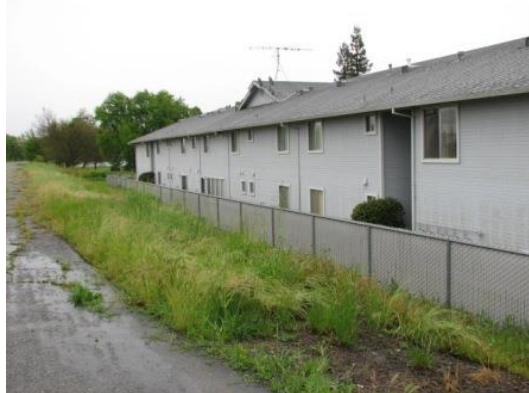
Photo 1 of 1 : SP_2015_NA0022_350_26_20150401_00029.jpg

The apartments and fence along the toe of the levee. Fall 2013

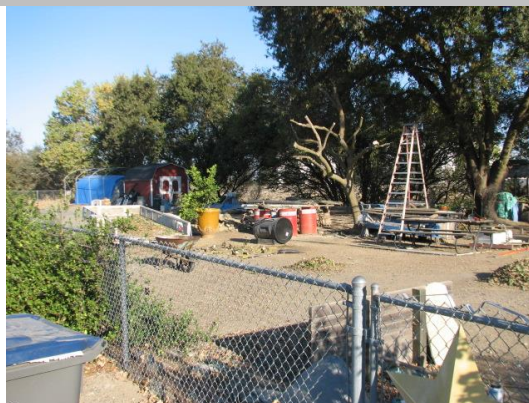
Photo 1 of 1 : SP_2015_NA0022_350_395_20150401_00059.jpg

LM Start	0.50	Rating **	M	Issue No.	395
LM End	0.54	Issue Type +	En	Location *	WS
Category	Earthen Levee			GPS Latitude/Longitude	
				Start	End
Item	Encroachments			38.802120 °	38.801882 °
				-121.716867 °	-121.716165 °
DWR ID	DWR_NA0022_01_f_2013_395				
Action/Comments					
Material

Material blocking visibility on the waterside of the levee. Fall 2013

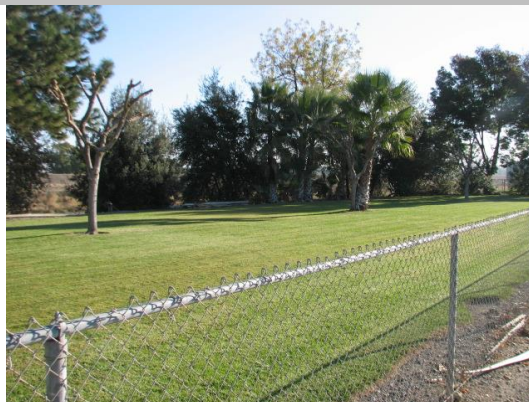
Photo 1 of 1 : SP_2015_NA0022_350_24_20150401_00027.jpg

The lawn area is on the levee waterside and crown. Fall 2013

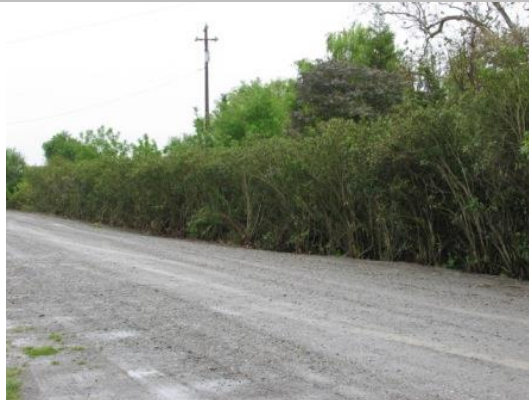
Photo 1 of 1 : SP_2015_NA0022_350_22_20150401_00025.jpg

Oleanders along the shoulder.

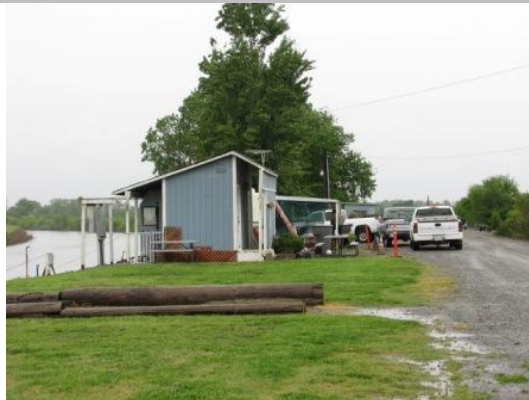
Photo 1 of 1 : SP_2015_NA0022_350_23_20150401_00026.jpg

LM Start	0.56	Rating **	A/W	Issue No.	23
LM End	0.64	Issue Type +	En	Location *	WS
Category	Earthen Levee			GPS Latitude/Longitude	
				Start	End
Item	Encroachments			38.801965 °	38.801468 °
				-121.715705 °	-121.714348 °
DWR ID	DWR_NA0022_01_s_2012_23				
Action/Comments					
Building					
Inspector Comments: Yolo Sutter Yacht Club

The Yacht club is on the crown. Fall 2013

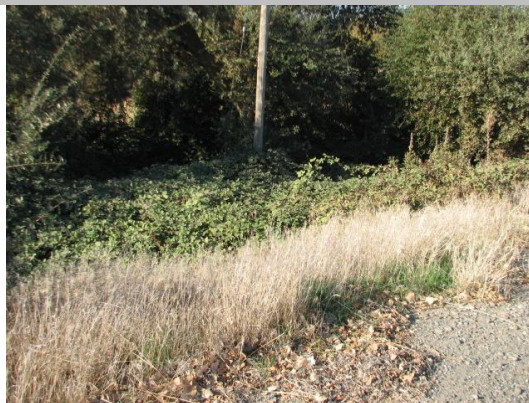
Photo 1 of 1 : SP_2015_NA0022_350_2_20150401_00002.jpg

The berries block visibility of the levee slope. Fall 2013

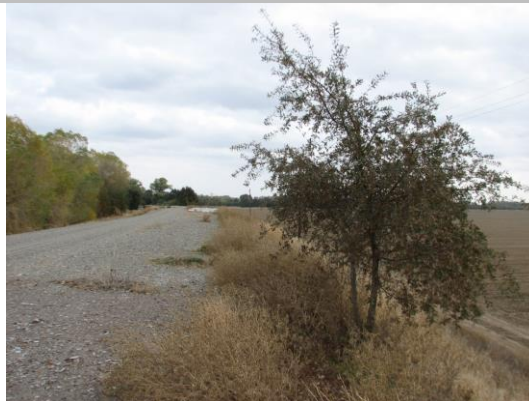
Photo 1 of 2 : SP_2015_NA0022_350_71_20150401_00054.jpg

Levee mile 0.75, vegetation on the land side slope. Fall 2014.

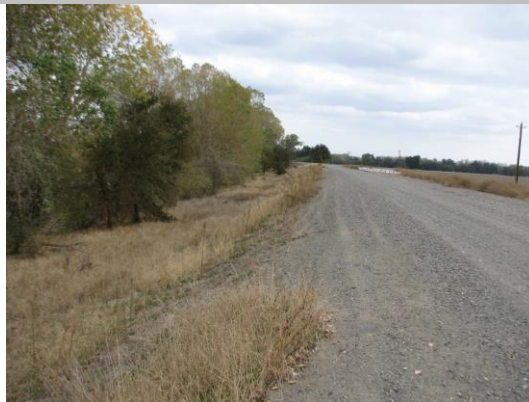
Photo 2 of 2 : SP_2015_NA0022_350_71_20150401_00055.jpg

LM Start	0.73	Rating **	M	Issue No.	71 (cont)
LM End	5.80	Issue Type +	Ma	Location *	WS

Levee mile 0.75, vegetation on the water side slope. Fall 2014.

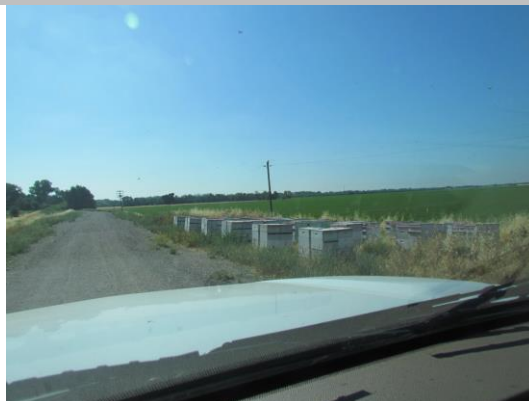
Photo 1 of 1 : SP_2015_NA0022_350_73_20150528_00062.jpg

View of the beehives on the landward side of the levee looking downstream. Spring 2015.

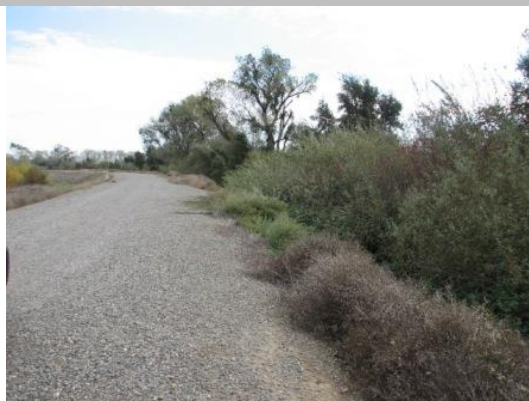
Photo 1 of 1 : SP_2015_NA0022_350_21_20150401_00024.jpg

LM Start	0.95	Rating **	U	Issue No.	21
LM End	1.12	Issue Type +	Ma	Location *	LS
Category	Earthen Levee			GPS Latitude/Longitude	
				Start	End
Item	Vegetation			38.800188 °	38.800577 °
				-121.708918 °	-121.705830 °
DWR ID	DWR_NA0022_01_s _ 2012_21				
Action/Comments					
Remove the wild growth other than native grasses from the levee slopes.

The vegetation completely blocks the view of the levee slope. Fall 2011

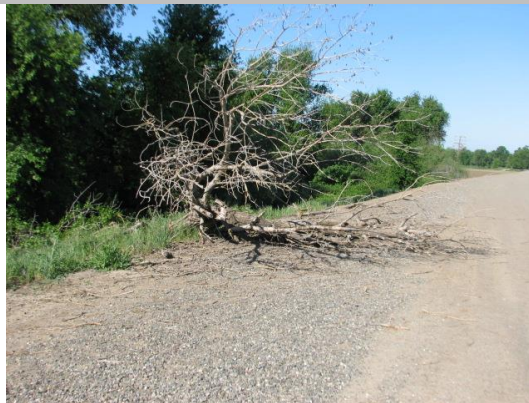
Photo 1 of 1 : SP_2015_NA0022_350_17_20150401_00020.jpg

A tree has fallen on the crown and blocks visibility. Spring 2014

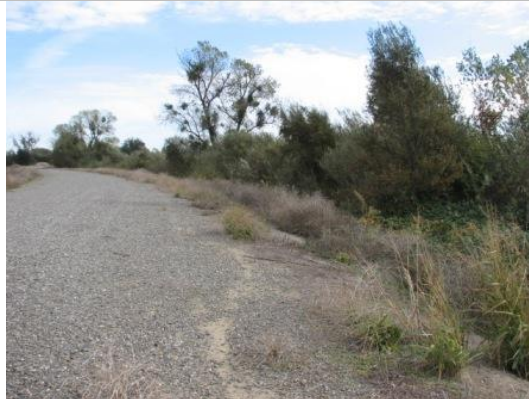
Photo 1 of 1 : SP_2015_NA0022_350_20_20150401_00023.jpg

The vegetation blocks the view of the levee slope. Fall 2011

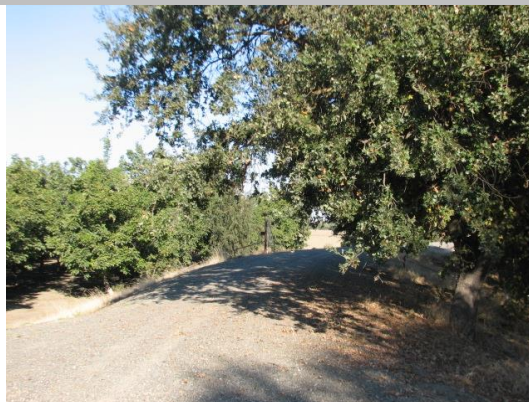
Photo 1 of 1 : SP_2015_NA0022_350_9_20150401_00013.jpg

Trees need to be trimmed up to 12 feet above the crown. Fall 2013

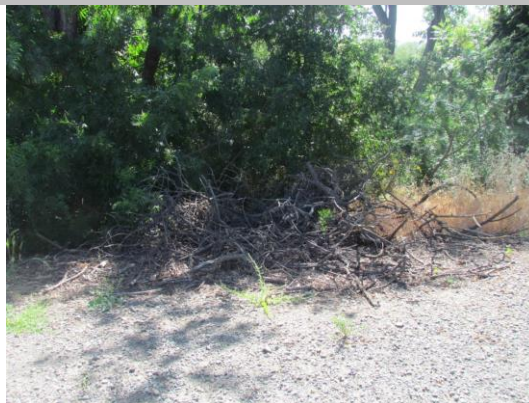
Photo 1 of 1 : SP_2015_NA0022_350_44_20150528_00063.jpg

View of the prunings on the waterward side of the levee. Spring 2015.

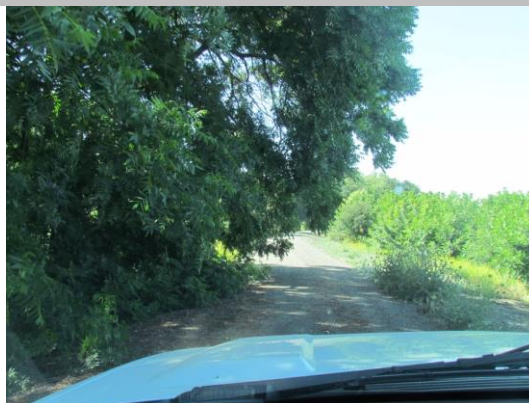
Photo 1 of 1 : SP_2015_NA0022_350_74_20150528_00064.jpg

View of the trees on the crown of the levee looking downstream. Spring 2015.

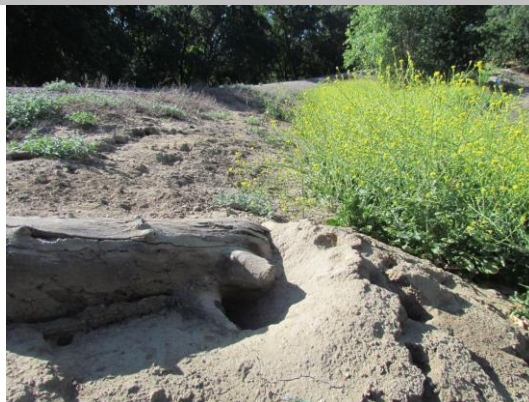
Photo 1 of 1 : SP_2015_NA0022_350_7_20150528_00065.jpg

View of the burrow on the landward side of the levee looking downstream. Spring 2015.

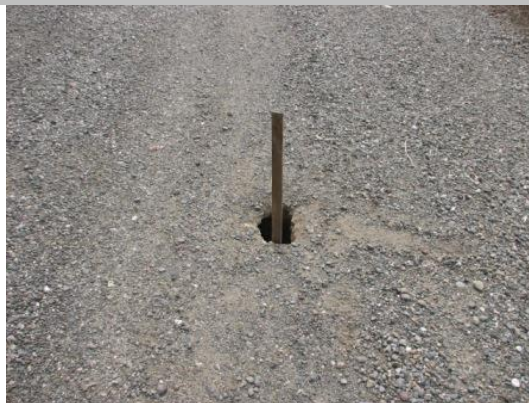
Photo 1 of 1 : SP_2015_NA0022_350_85_20150401_00056.jpg

A rodent hole in the crown of the levee. Fall 2011

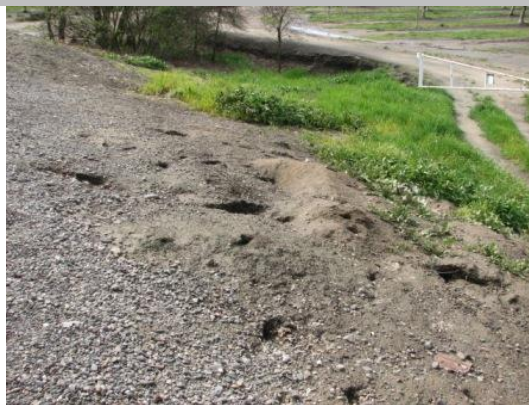
Photo 1 of 1 : SP_2015_NA0022_350_8_20150401_00012.jpg

There are multiple rodent holes but no visible rodents. Need to backfill and compact.

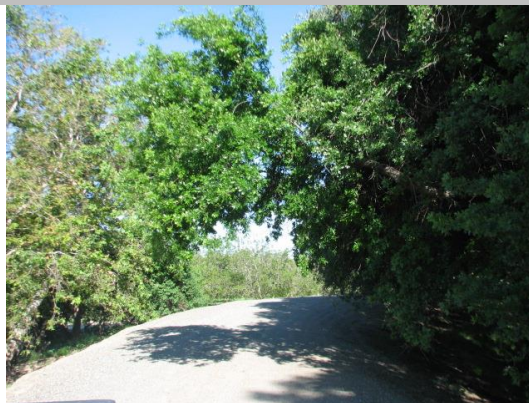
Photo 1 of 1 : SP_2015_NA0022_350_25_20150401_00028.jpg

Trees need to be trimmed up to at least 12 feet above the crown. Spring 2014

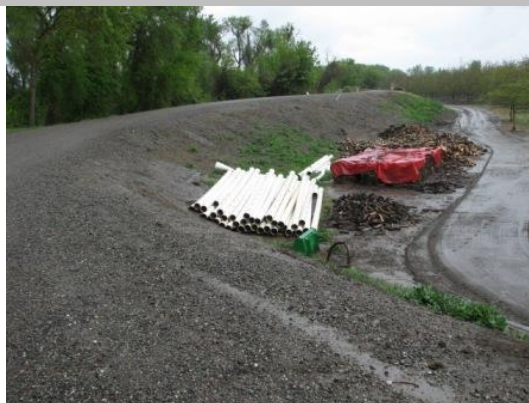
Photo 1 of 1 : SP_2015_NA0022_350_40_20150401_00044.jpg

Pipe along toe.

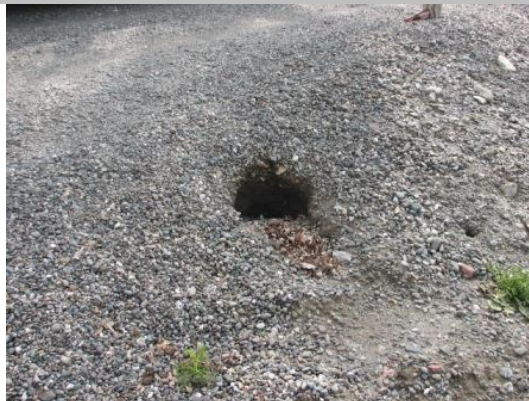
Photo 1 of 1 : SP_2015_NA0022_350_35_20150401_00037.jpg

A rodent hole needs to be backfilled and compacted.

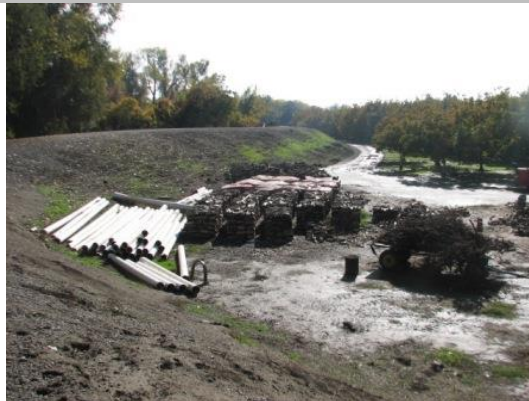
Photo 1 of 2 : SP_2015_NA0022_350_39_20150401_00042.jpg

The firewood pile is continuing to grow along the toe of the levee. Fall 2012

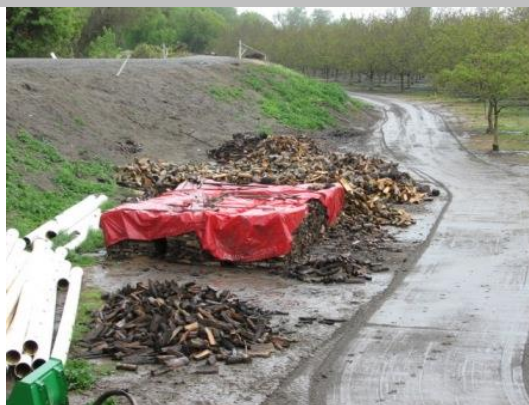
Photo 2 of 2 : SP_2015_NA0022_350_39_20150401_00043.jpg

Firewood stacked up.

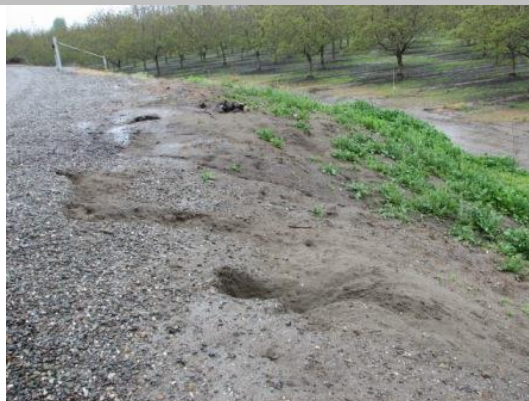
Photo 1 of 1 : SP_2015_NA0022_350_41_20150401_00045.jpg

Rodents

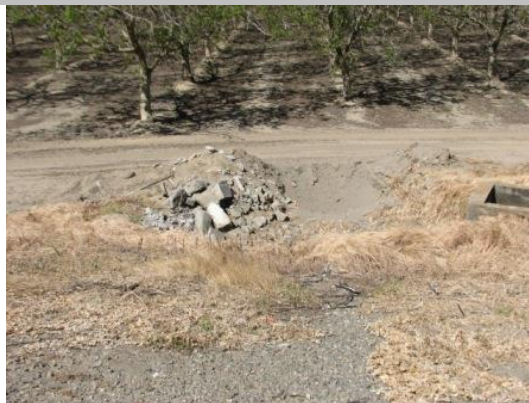
Photo 1 of 1 : SP_2015_NA0022_350_45_20150401_00051.jpg

Concrete debris is at the toe of the levee. Spring 2013

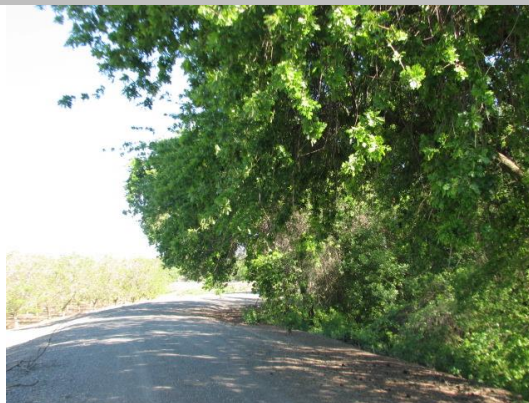
Photo 1 of 1 : SP_2015_NA0022_350_32_20150401_00036.jpg

Trees need to be trimmed up to at least 12 feet above the crown. Spring 2014

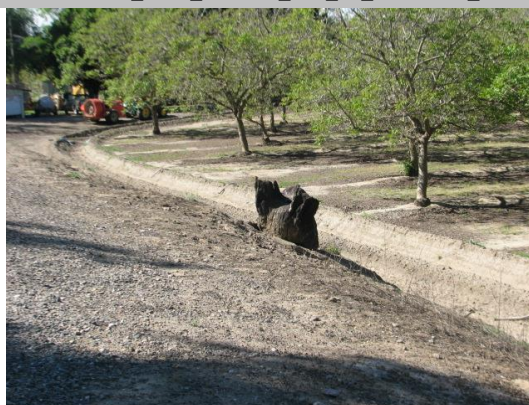
Photo 1 of 1 : SP_2015_NA0022_350_37_20150401_00041.jpg

Tree stump decomposing and may pose a risk to the levee. Spring 2014

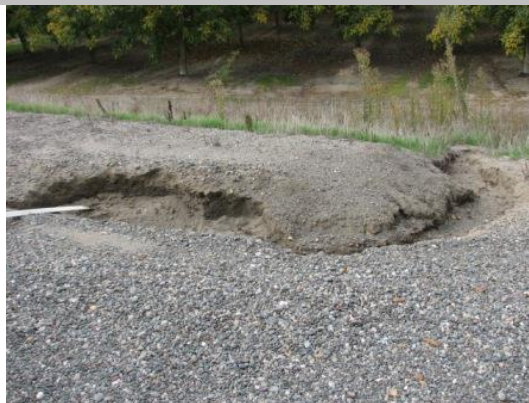
Photo 1 of 1 : SP_2015_NA0022_350_87_20150401_00057.jpg

Erosion caused by a build up of water then running off the slope. Fall 2011

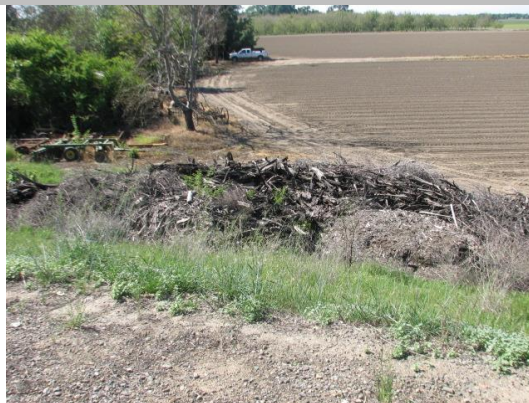
Photo 1 of 1 : SP_2015_NA0022_350_42_20150401_00046.jpg

A large pruning pile near the toe of the levee. Spring 2014

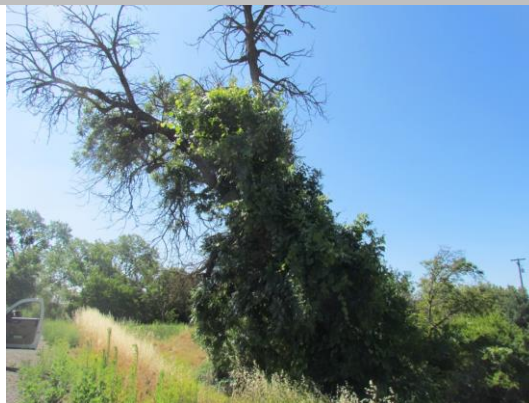
Photo 1 of 1 : SP_2015_NA0022_350_77_20150528_00066.jpg

View of the dying tree on the landward side of the levee looking downstream. Spring 2015.

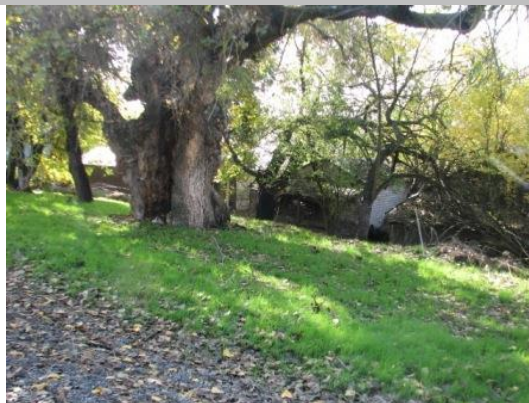
Photo 1 of 2 : SP_2015_NA0022_350_12_20150401_00015.jpg

Buildings are located at the toe of the levee. Fall 2012

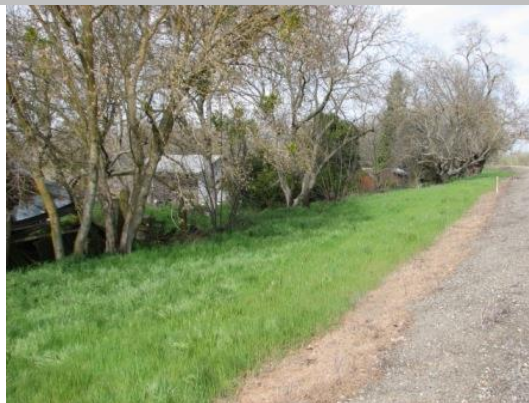
Photo 2 of 2 : SP_2015_NA0022_350_12_20150401_00016.jpg

The buildings are encroaching into the levee slope.

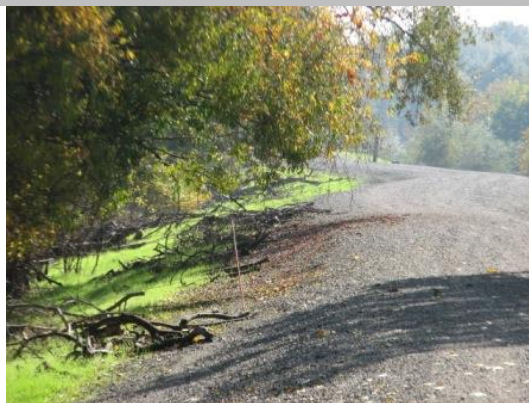
Photo 1 of 2 : SP_2015_NA0022_350_30_20150401_00034.jpg

Many piles are on the slope. Fall 2012.

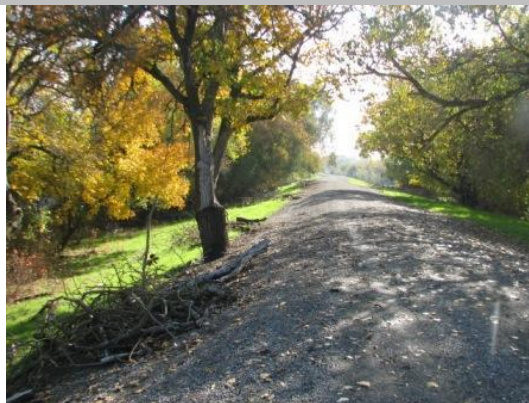
Photo 2 of 2 : SP_2015_NA0022_350_30_20150401_00035.jpg

Piles of prunings are on the waterside slope. Fall 2012

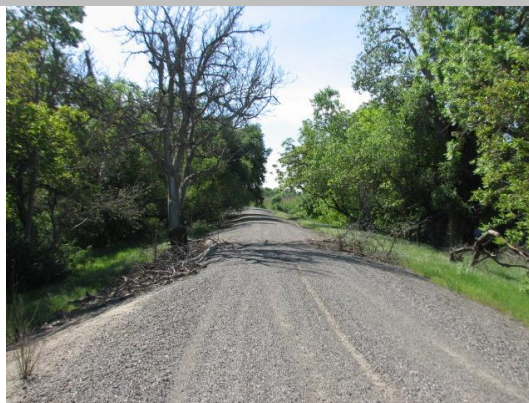
Photo 1 of 1 : SP_2015_NA0022_350_43_20150401_00047.jpg

A tree is dying and needs to be monitored as it may pose a threat to the levee. Spring 2014

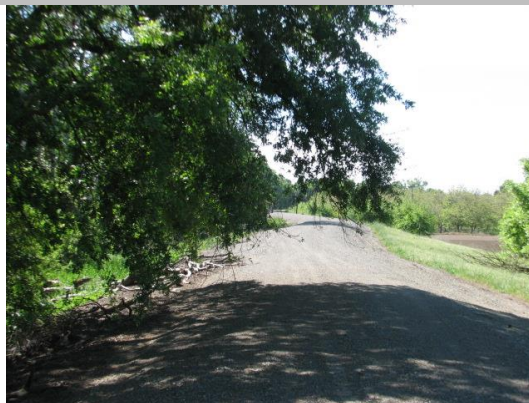
Photo 1 of 1 : SP_2015_NA0022_350_46_20150401_00052.jpg

Trees need to be trimmed up to at least 12 feet above the crown. Spring 2014

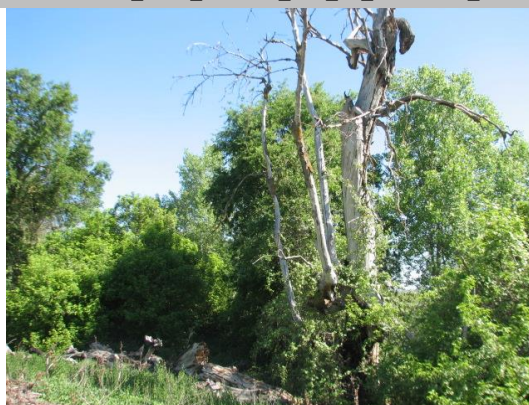
Photo 1 of 2 : SP_2015_NA0022_350_47_20150401_00053.jpg

Trees have fallen and others are dying need to be monitor. They may pose a threat to the levee. Spring 2014

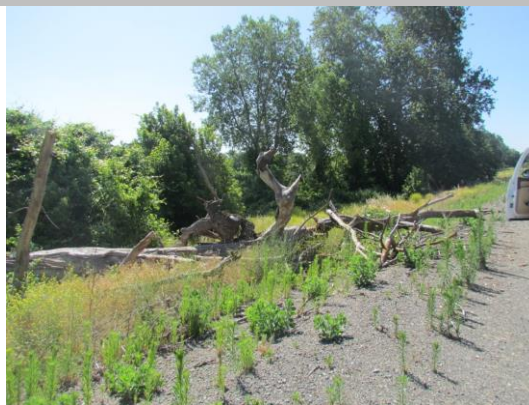
Photo 2 of 2 : SP_2015_NA0022_350_47_20150528_00067.jpg

View of the fallen tree on the waterward side of the levee looking downstream. Spring 2015.

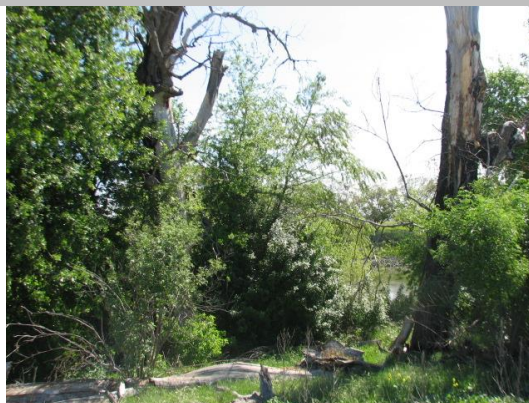
Photo 1 of 1 : SP_2015_NA0022_350_15_20150401_00019.jpg

Monitor dying trees they may pose to be a threat to the levee. Spring 2014

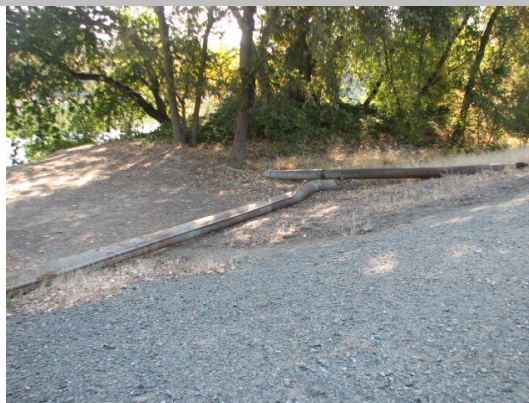
Photo 1 of 1 : SP_2015_NA0022_350_401_20150401_00060.jpg

Pipe has been laid on the waterside berm. Fall 2013

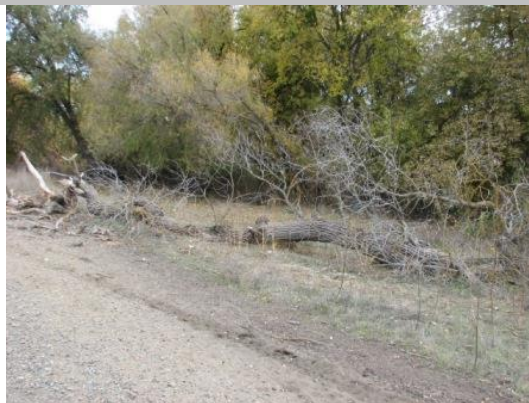
Photo 1 of 1 : SP_2015_NA0022_350_89_20150401_00058.jpg

Another tree has fallen on the waterside slope. Fall 2011

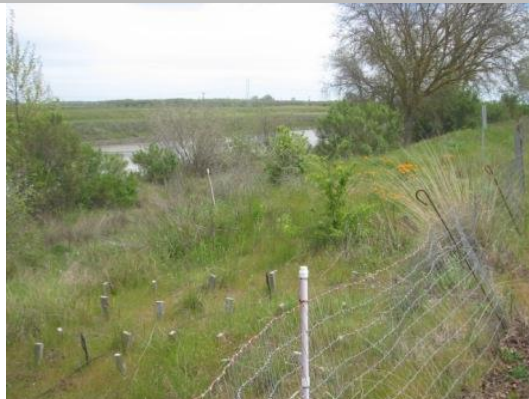
Photo 3 of 3 : SP_2015_NA0022_350_36_20150401_00040.jpg

Fence, irrigation and stakes in the revegetation site.

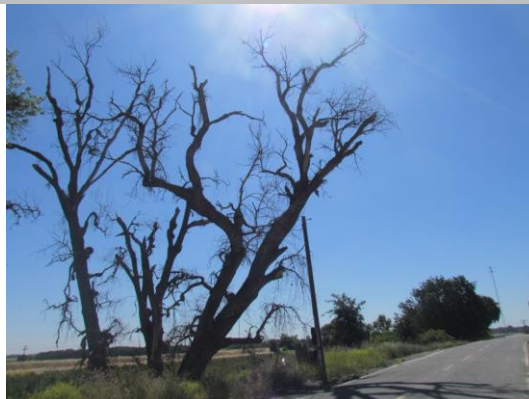
Photo 1 of 1 : SP_2015_NA0022_350_81_20150528_00069.jpg

View of the dying tree on the waterward side of the levee looking downstream. Spring 2015.

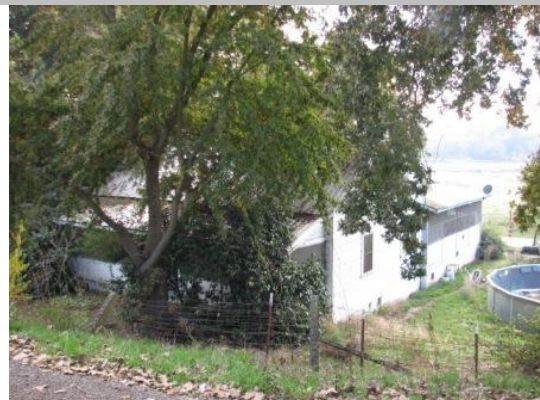
Photo 1 of 1 : SP_2015_NA0022_350_1_20150401_00001.jpg

The house and landscape are in the easment of the levee. Fall 2011

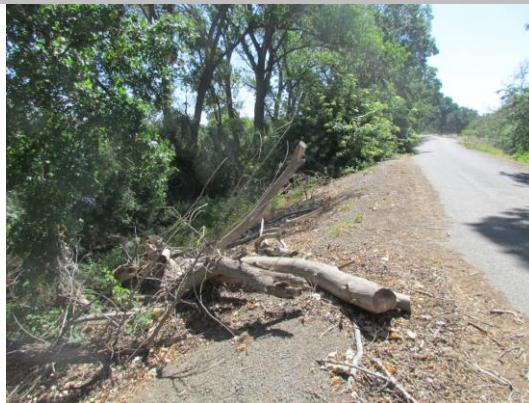
Photo 1 of 1 : SP_2015_NA0022_350_82_20150528_00070.jpg

View of the fallen tree on the waterward side of the levee looking downstream. Spring 2015.

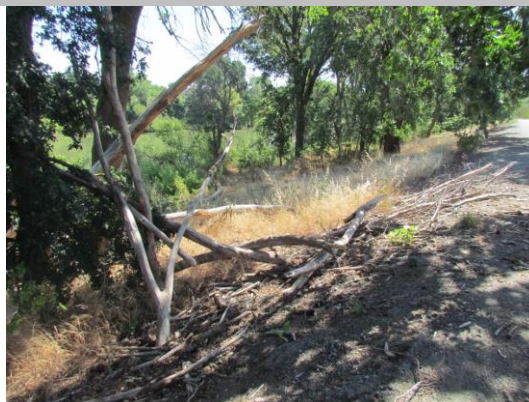
Photo 1 of 1 : SP_2015_NA0022_350_83_20150528_00071.jpg

View of the tree and tree limbs on the waterward side of the levee looking downstream. Spring 2015.

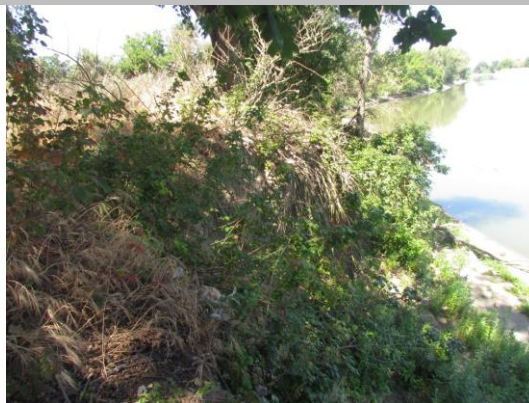
Photo 1 of 2 : SP_2015_NA0022_350_84_20150528_00072.jpg

View of the erosion on the waterward side of the levee looking upstream. Spring 2015.

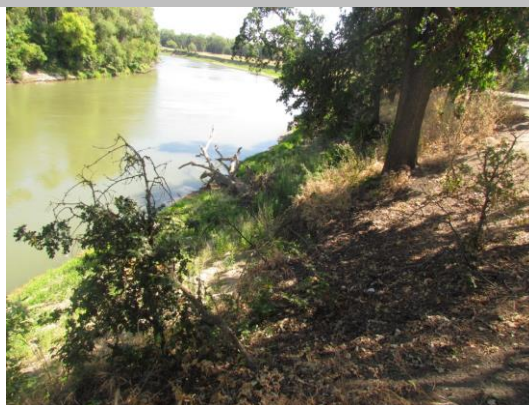
Photo 2 of 2 : SP_2015_NA0022_350_84_20150528_00073.jpg

View of another erosion on the waterward side of the levee looking downstream. Spring 2015.
